Historic Structure Report

**SAINT JOSEPH HALL
(THE POLISH CLUB)
HISTORIC STRUCTURE REPORT**

**Salem Maritime National Historic Site
Salem, Massachusetts**

Building Conservation Branch, Northeast Cultural Resources Center
Northeast Region, National Park Service
U.S. Department of the Interior
Lowell, Massachusetts

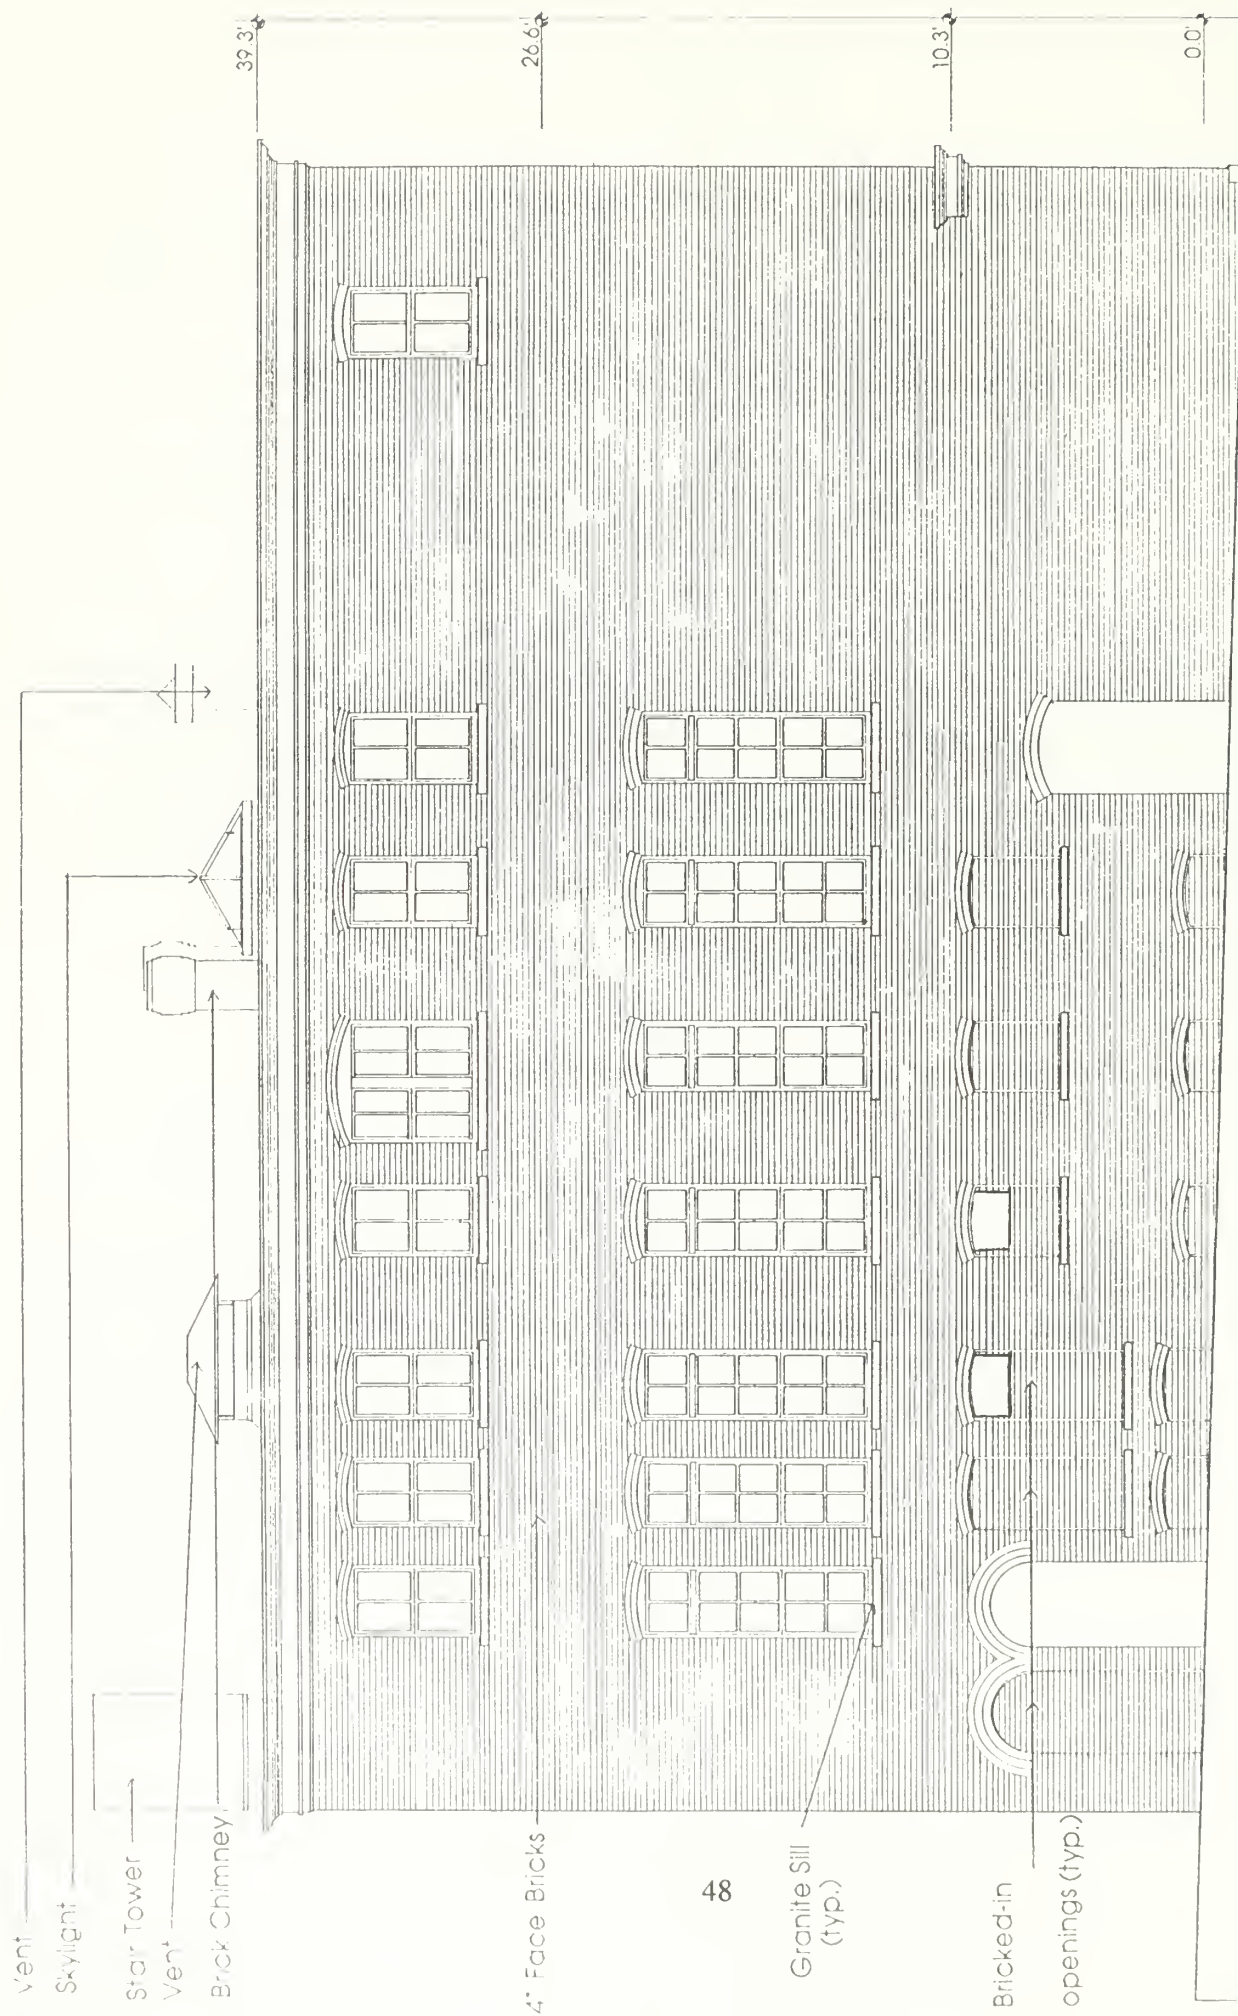
The west elevation (fig. 21) has brick siding that extends from the heavy molded roof cornice to the sidewalk, with no foundation being visible. The first story has three original doorway openings: two adjacent round-arched openings at the north end, and one segmentally arched opening at the south end. The northernmost doorway was bricked up ca. 1950; the southernmost doorway was boarded up in the 1960s. The remaining doorway was fitted with a steel-clad exit door ca. 1960.

Figure 21. Polish Club building: west elevation.

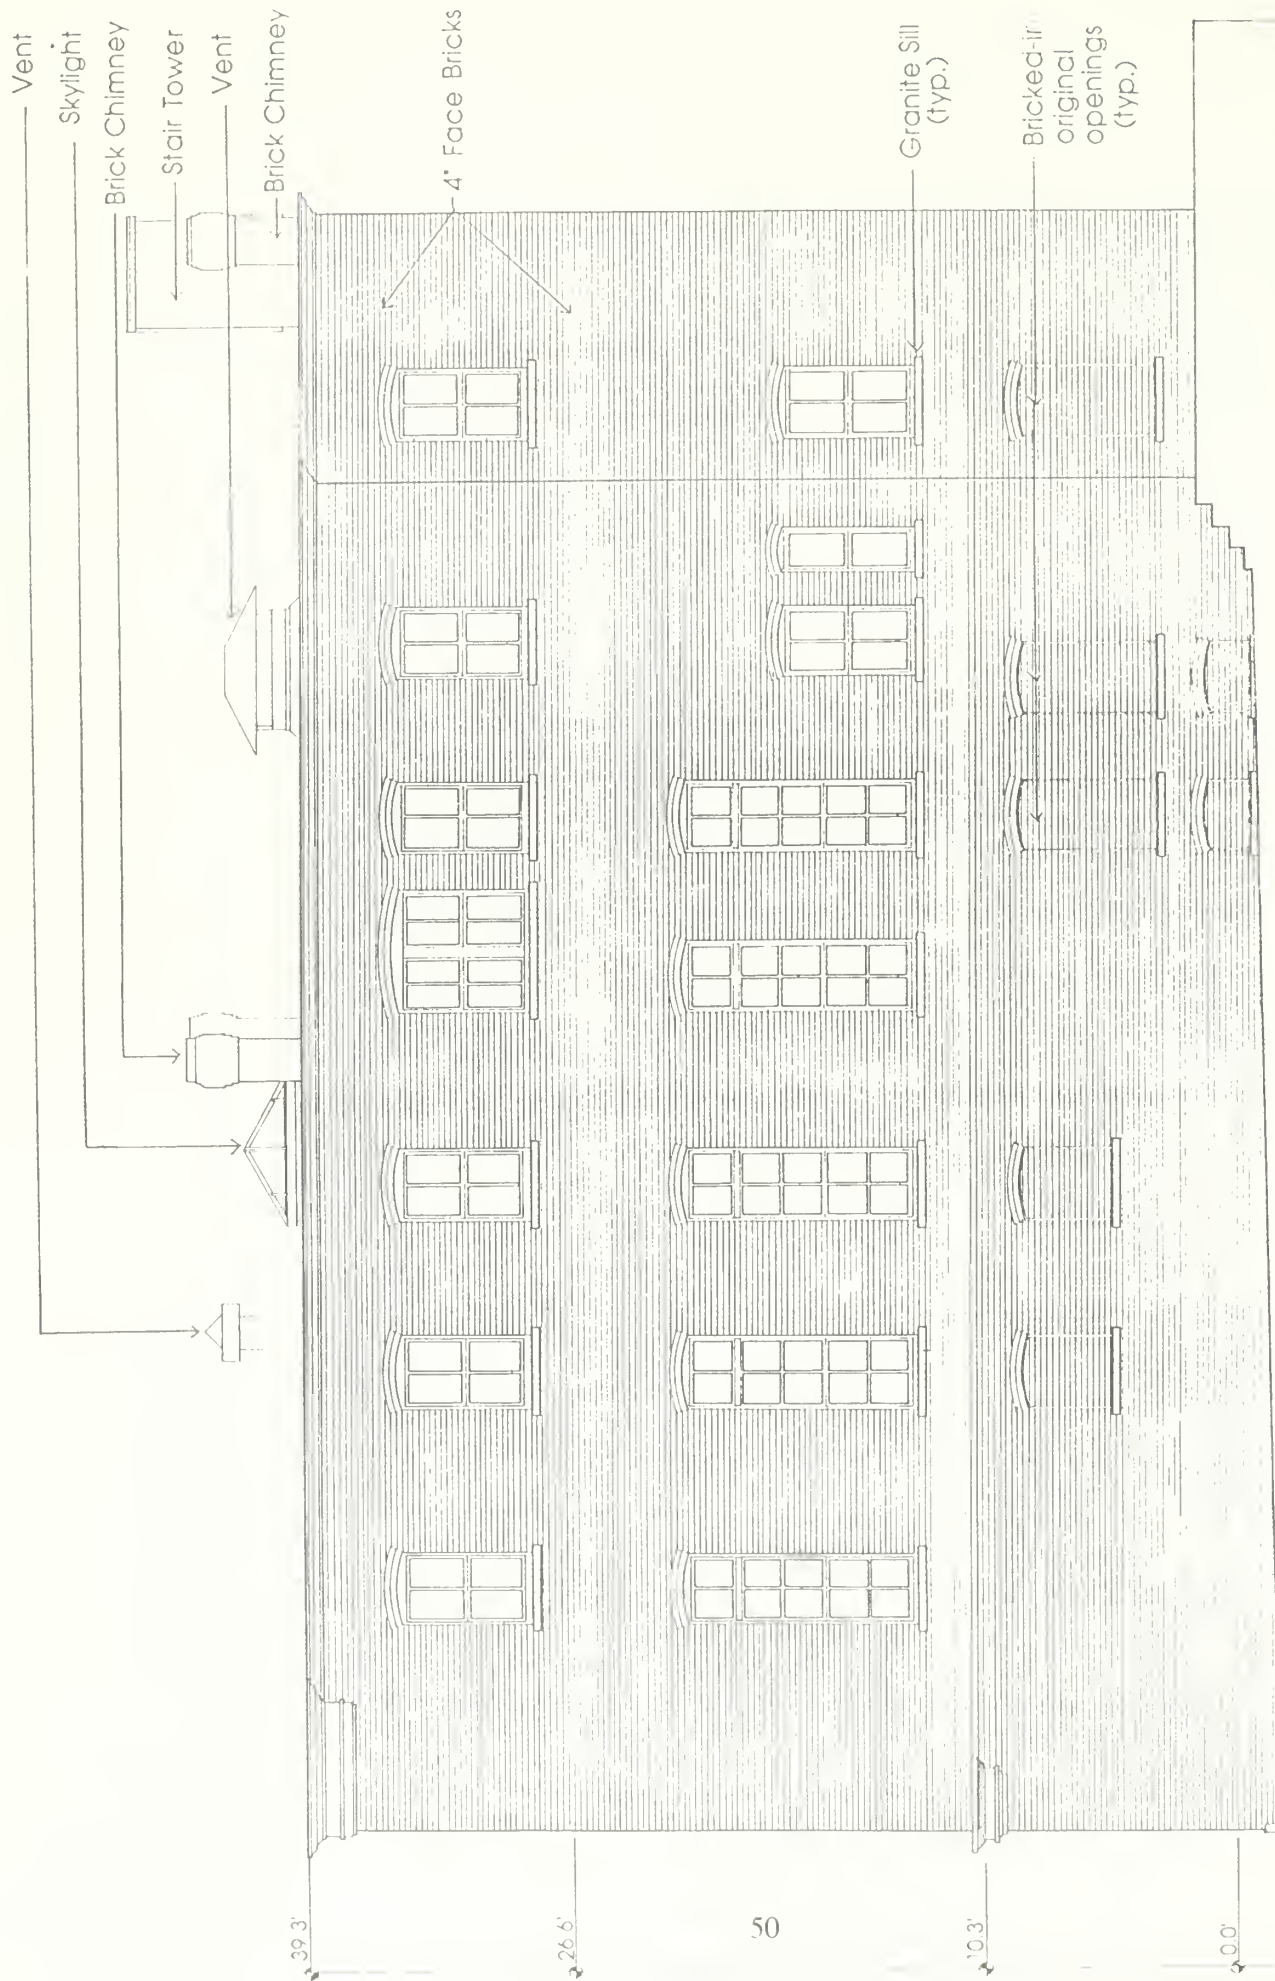
The east elevation (fig. 23) faces a narrow dead-end alley. Nevertheless, it has several distinguishing features. For example, both the roof and the storefront cornices on the south elevation return onto this elevation. The brick wall steps back at the far north end; there is no foundation visible.

Figure 23. Polish Club building: east elevation.

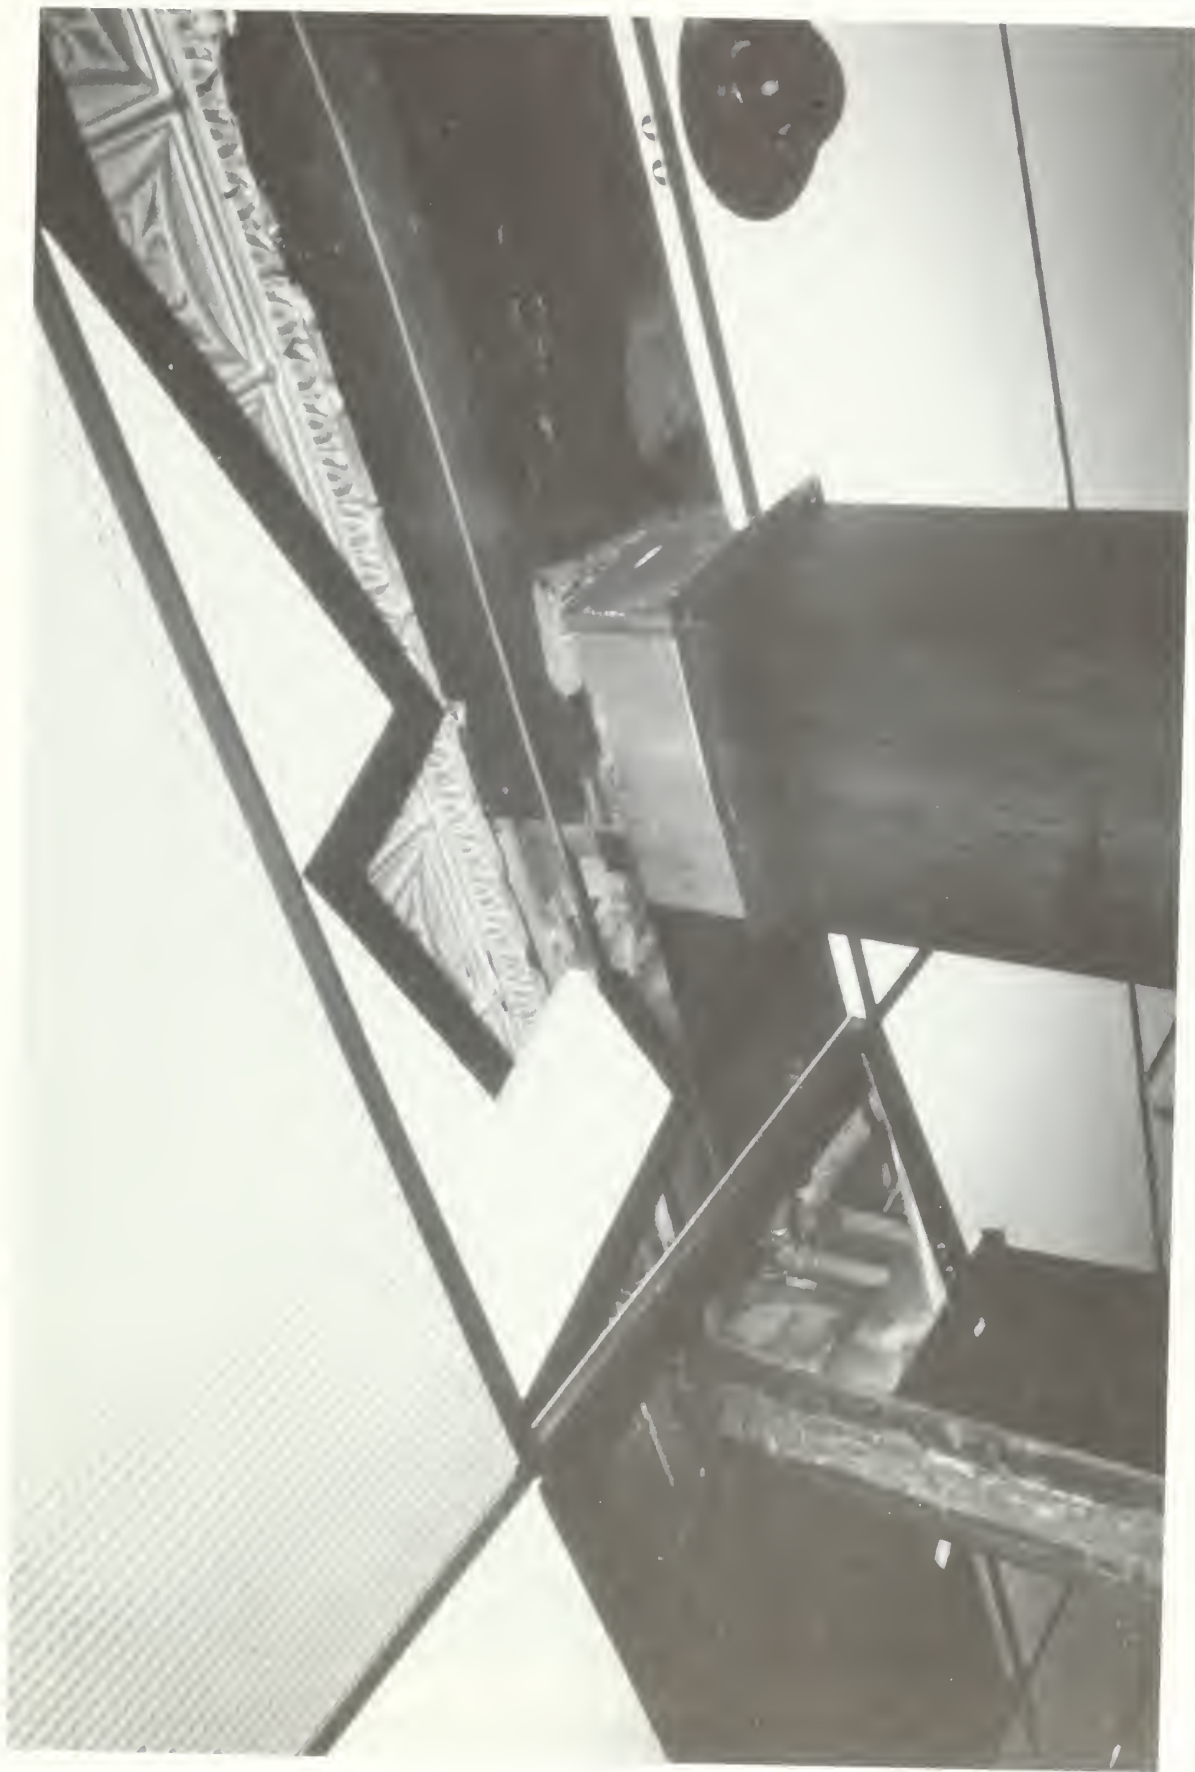
Figure 27. Room 101 (Club Room), exposed beam.

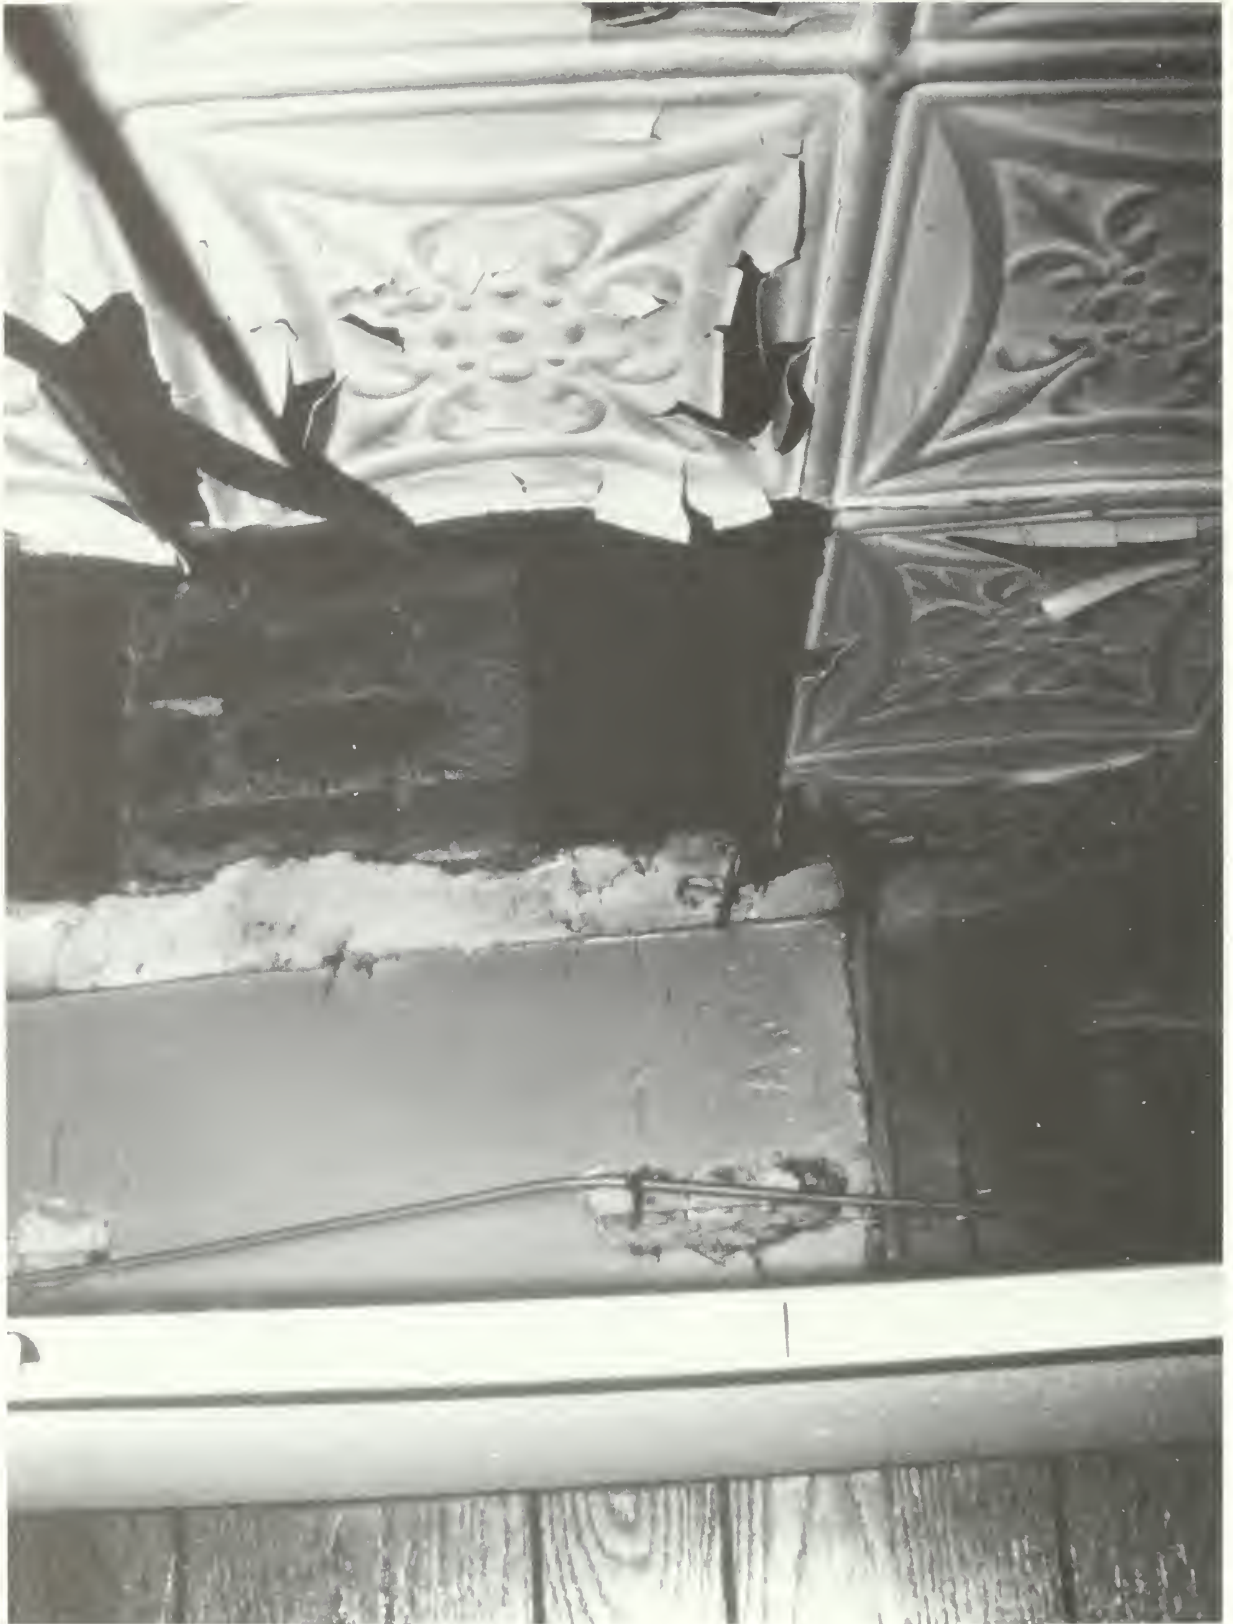
Figure 28. Room 101, exposed pressed-metal ceiling.

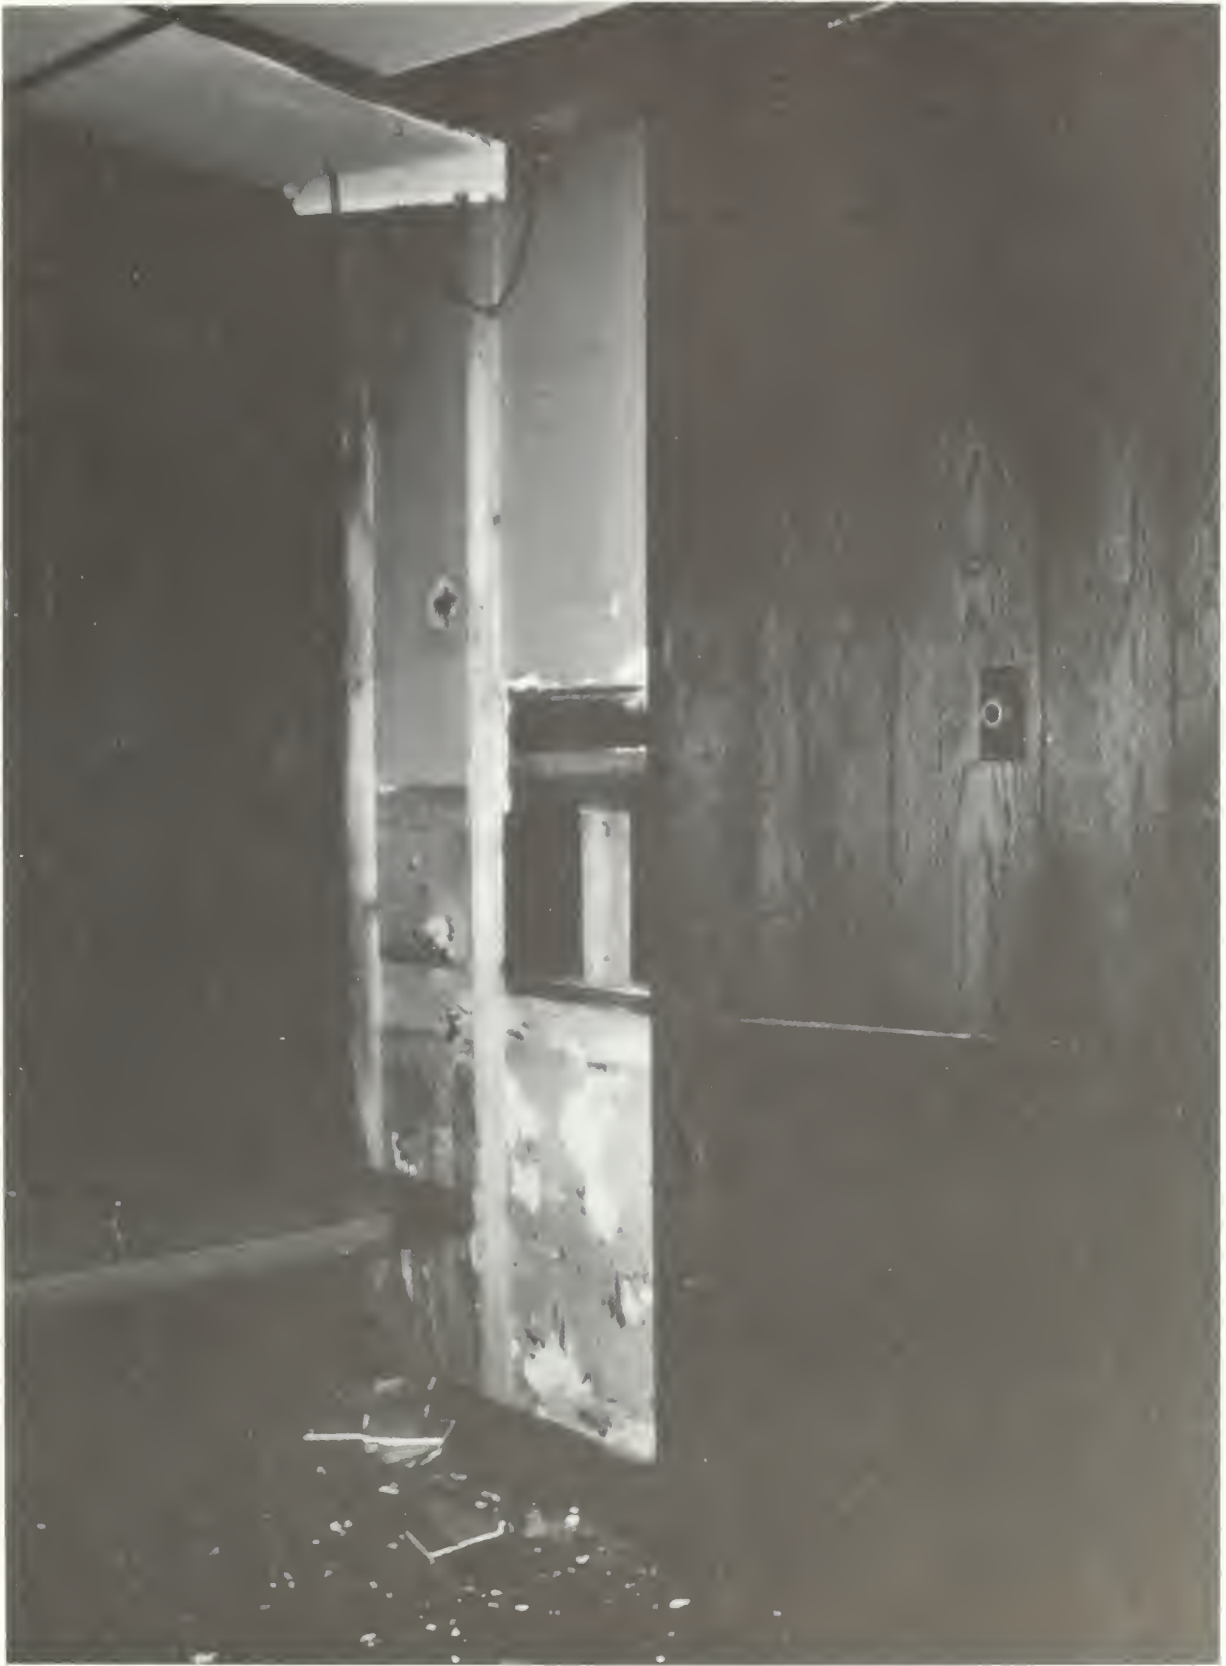
Figure 29. Room 101, exposed ticket window.

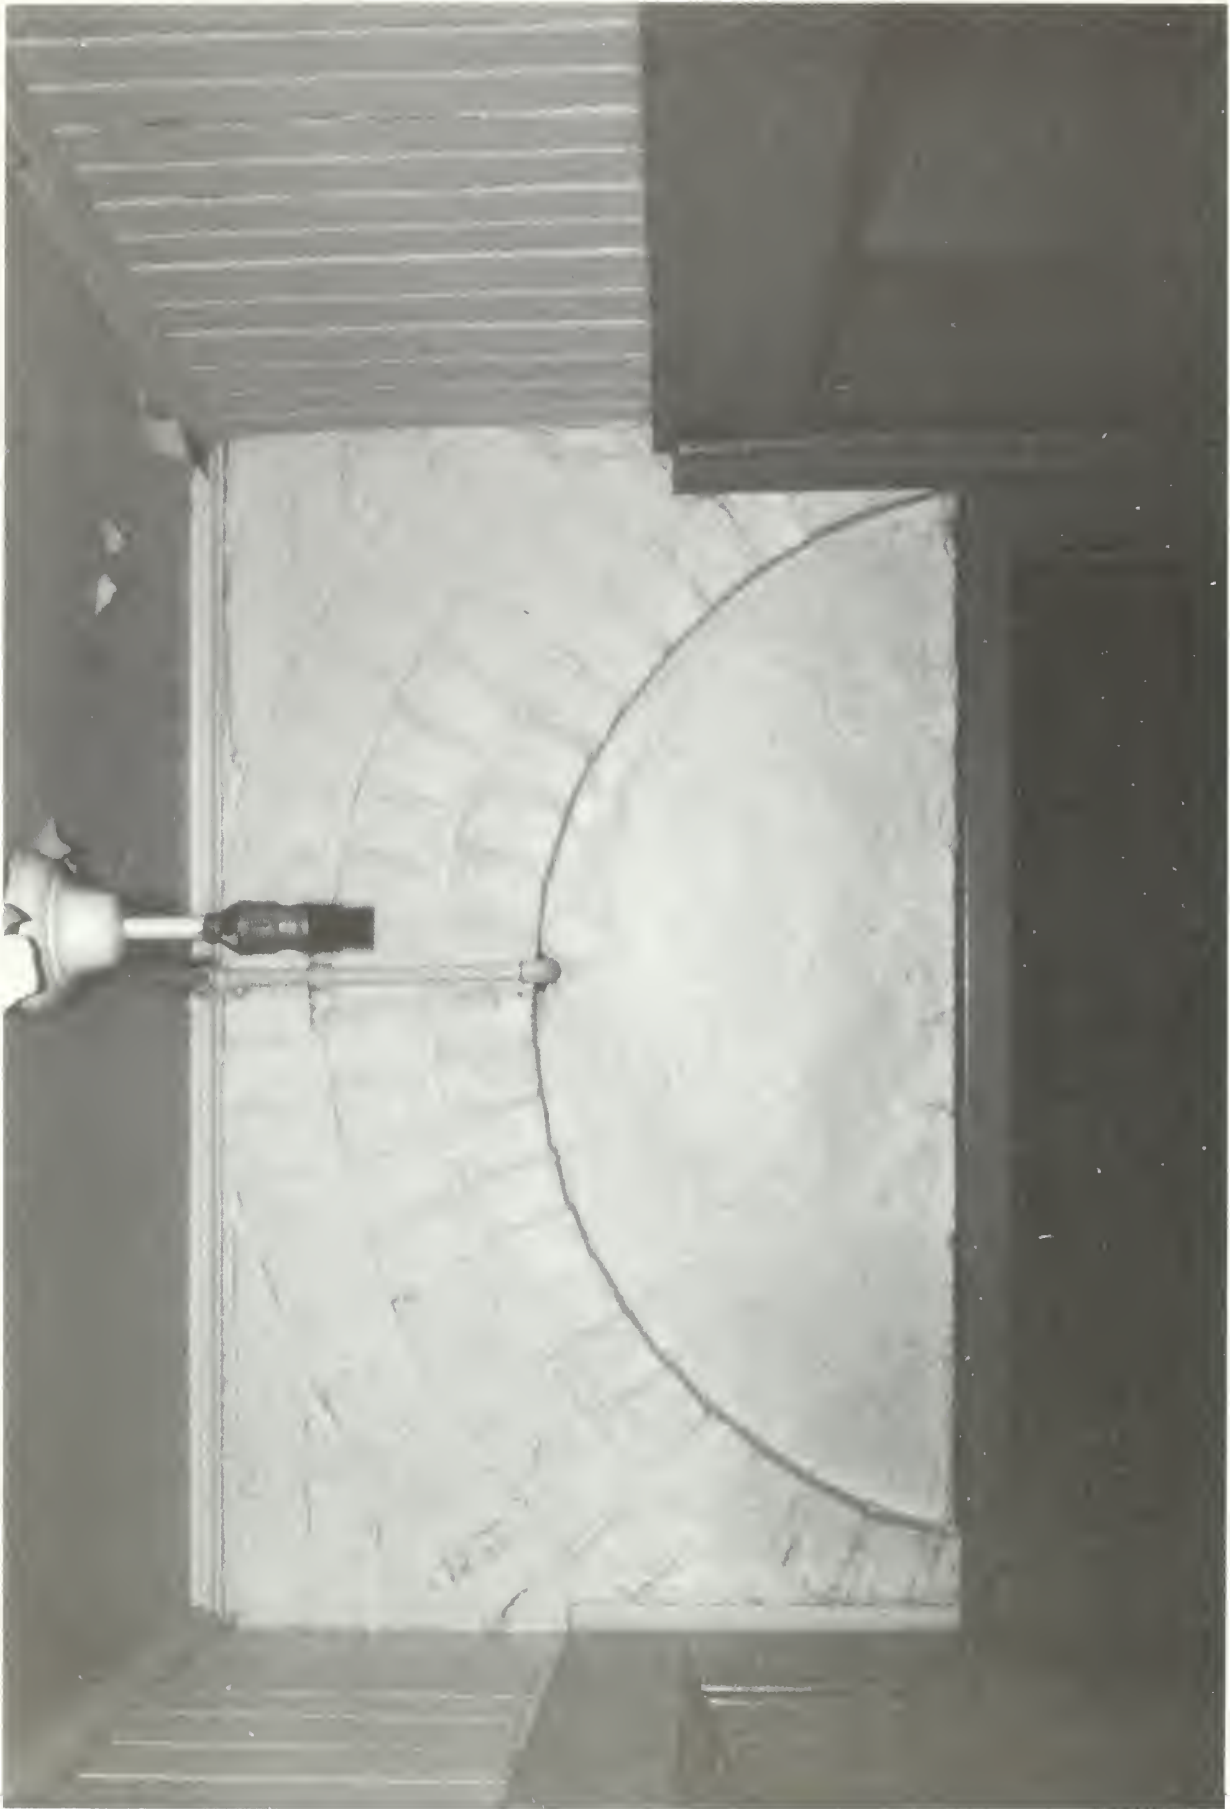
Figure 30. Room 114 (Rear Stairway), arched lintel of exterior doorway.

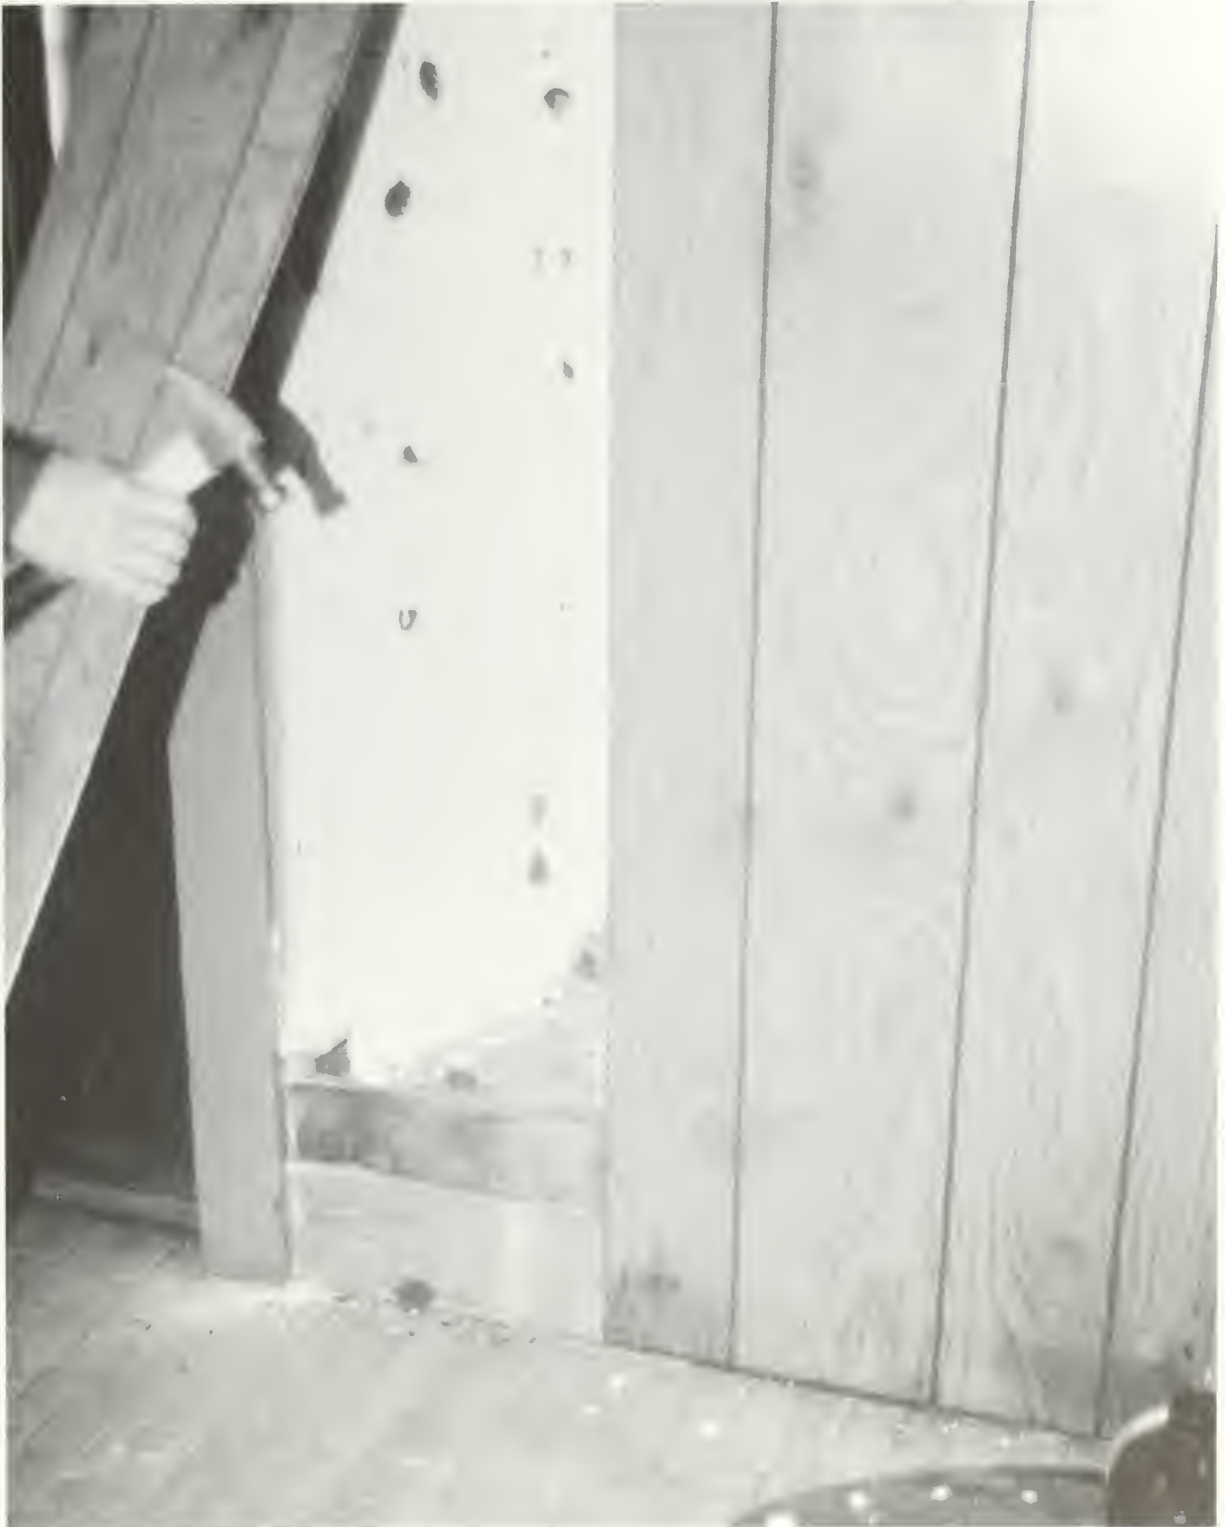
Figure 36. Room 201, ghost of stage steps.

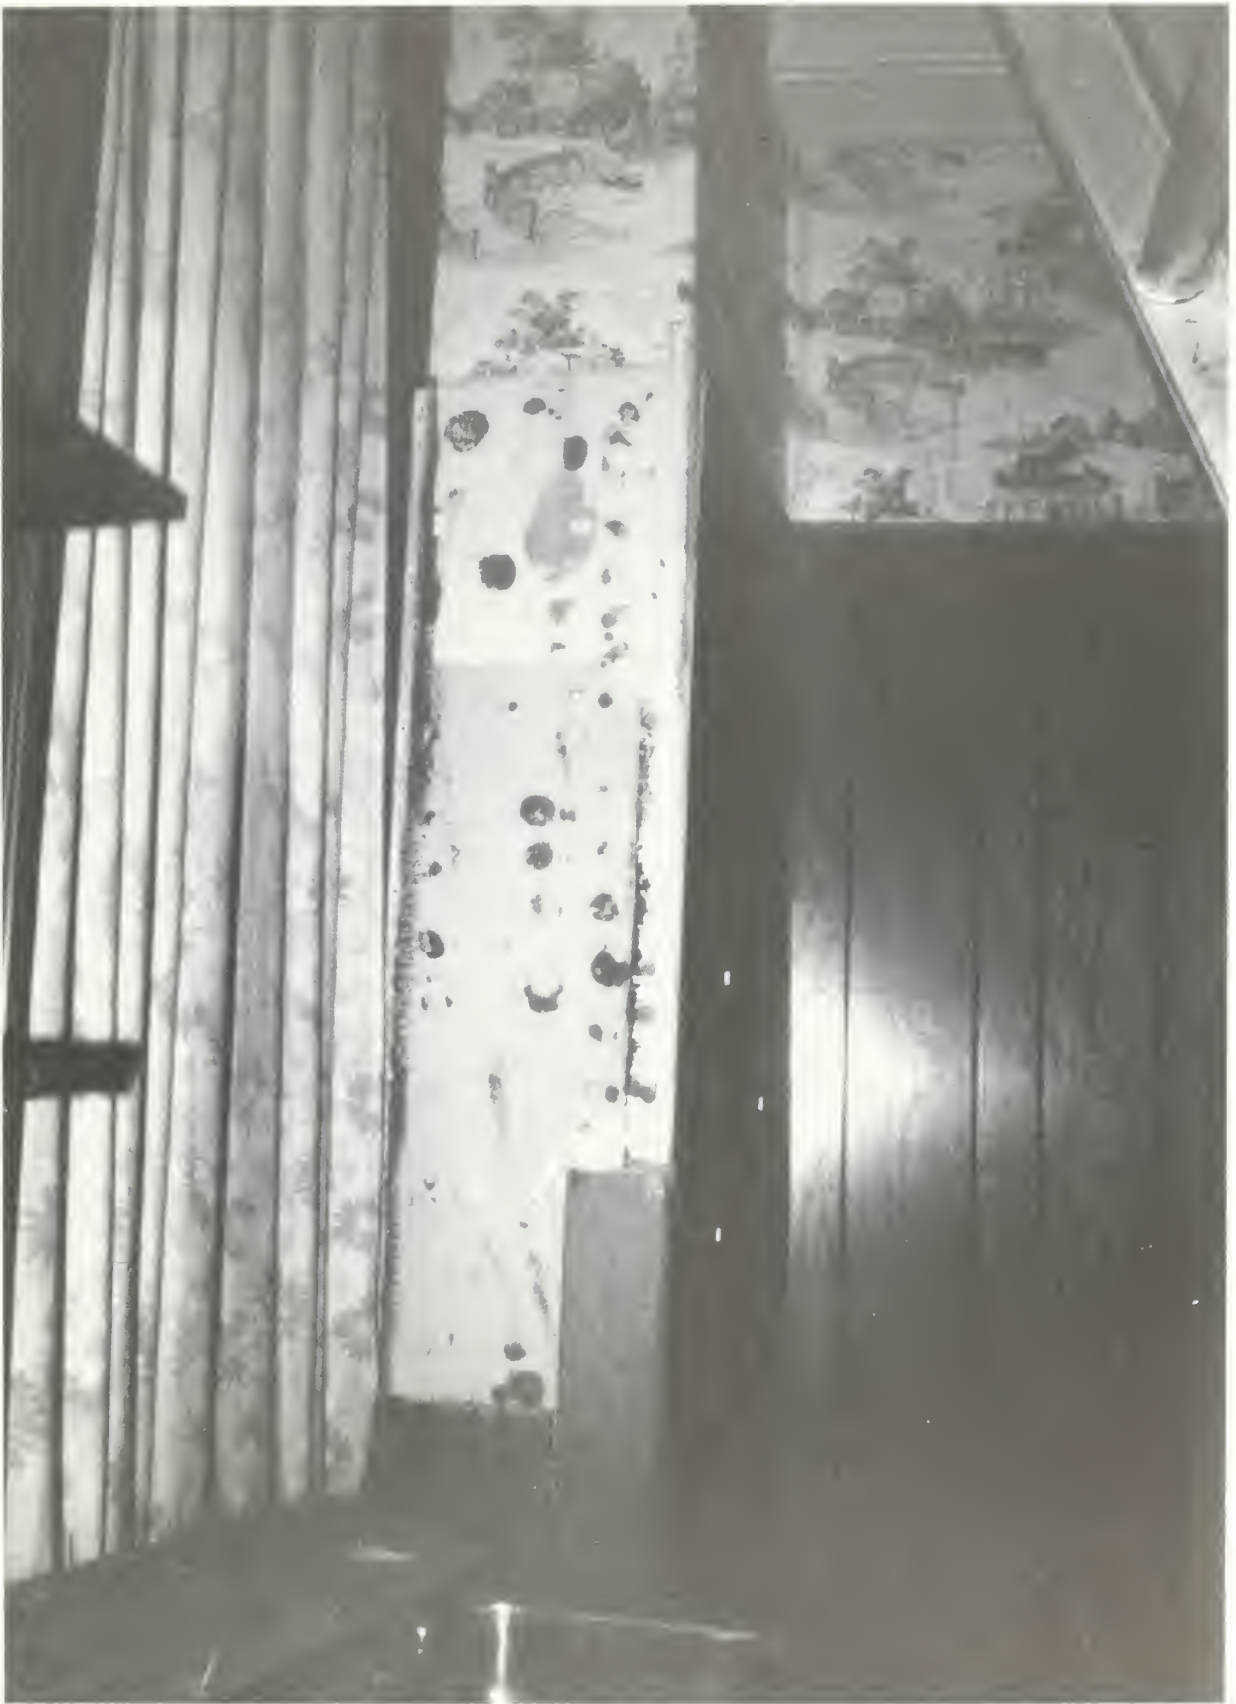
Figure 38. Room 201, west wall, exposed area showing fragment of original wall stenciling.
